Technical Note ZMR-2-19

January 1998

Comparison of the Component-Level Performance of Anti-Zebra Mussel Coating Systems with Research Coupon Results

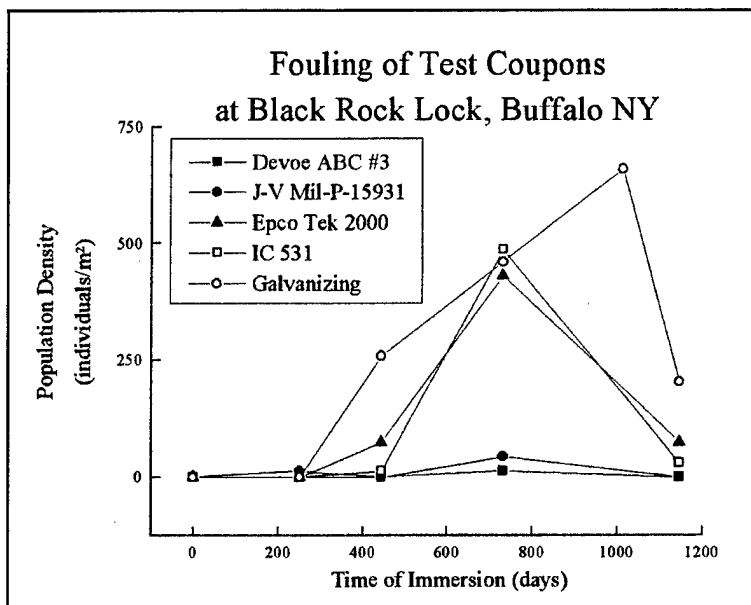
Figure 1 plots the population densities (zebra mussels per square meter) that have infested the test coupons at Black Rock Lock over time. The two copper oxide-containing coatings (Devoe ABC No. 3 and J-V Mil-P-15931) had essentially no zebra mussels during the 3-year test. Infestations on the other coatings seem to have peaked, and are now retreating.

Figure 1. Population density of zebra mussels over time during immersion at Black Rock Lock for copper- and zinc-bearing coatings

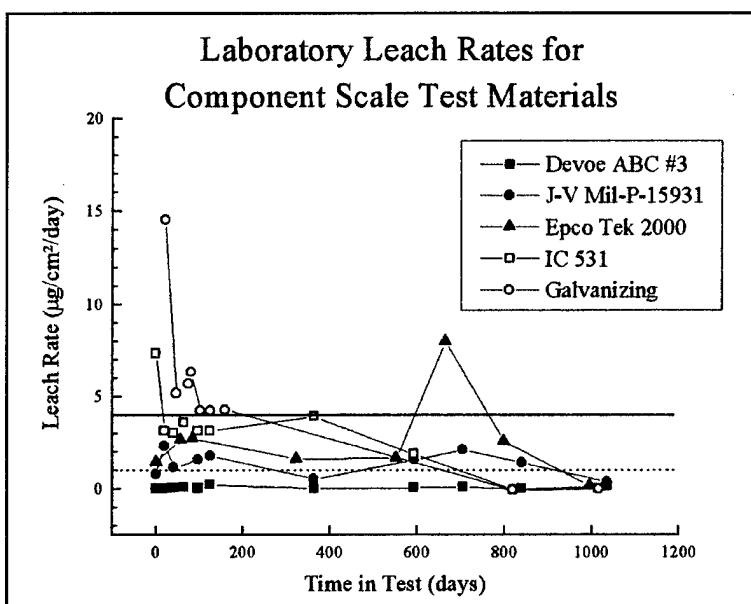
The leach rates of the primary antifouling metal ion, as a function of the time of immersion in flowing water, for the five laboratory-tested coatings are shown in Figure 2. The minimum values of the leach rate estimated for maintaining the antifouling properties in copper- and zinc-bearing coatings are also plotted.

Figure 2. Leach rates of metal ion from copper- and zinc-bearing coatings, measured at intervals over a 3-year period. Horizontal lines indicate the estimated minimum values of leach rate for maintenance of antifouling properties in coatings (dashed line = copper; solid line = zinc-bearing coating)

As laboratory zinc leach rates have fallen, the infestation density has risen at Black Rock Lock. The bars on the trash racks at Markland Lock and Dam have not been coated long enough for the leach rates to have diminished significantly. It is anticipated that the use of thermal-sprayed zinc or zinc alloy materials would work similarly to the inorganic zinc material. These materials might be more abrasion resistant, adhere better, and provide better corrosion inhibition for a longer period.
